OSHA FALL PROTECTION TEST REPORT

VELUX AMERICA INC.

SERIES/MODEL: CM

Report No: 88221.01-109-44

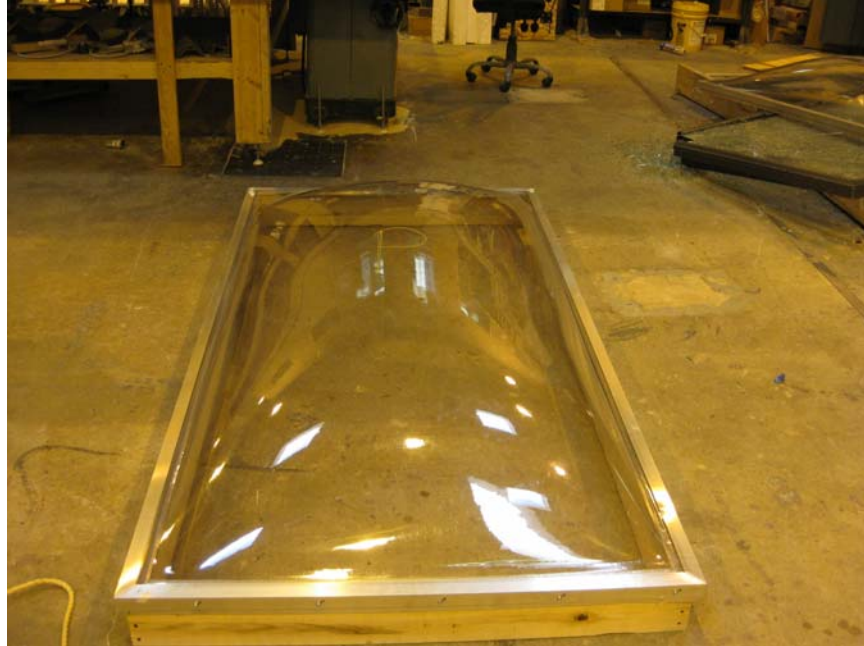
Photo No. 1
48 x 96 Polycarbonate Glazed Skylight Before Testing

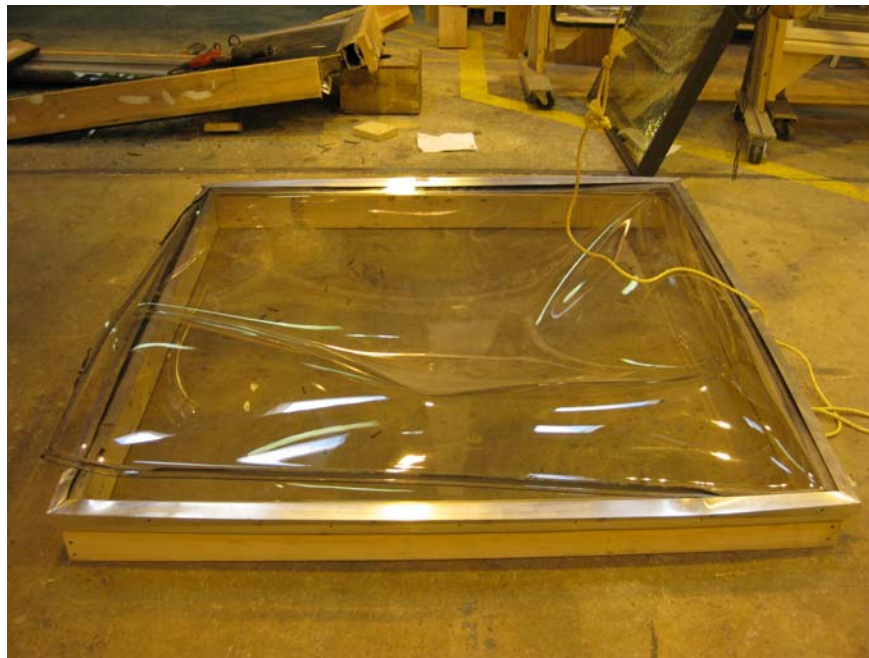
***Note #2:** At the 4' drop height, the polycarbonate dome deglazed from the frame. The weight of the fall did not allow the load to fall through the skylight.*

Photo No. 2
72 x 72 Polycarbonate Glazed Skylight After Testing
